ACTIONS for CLEAN WATER PLAN

ACWA PLAN

6.1 Condition assessments

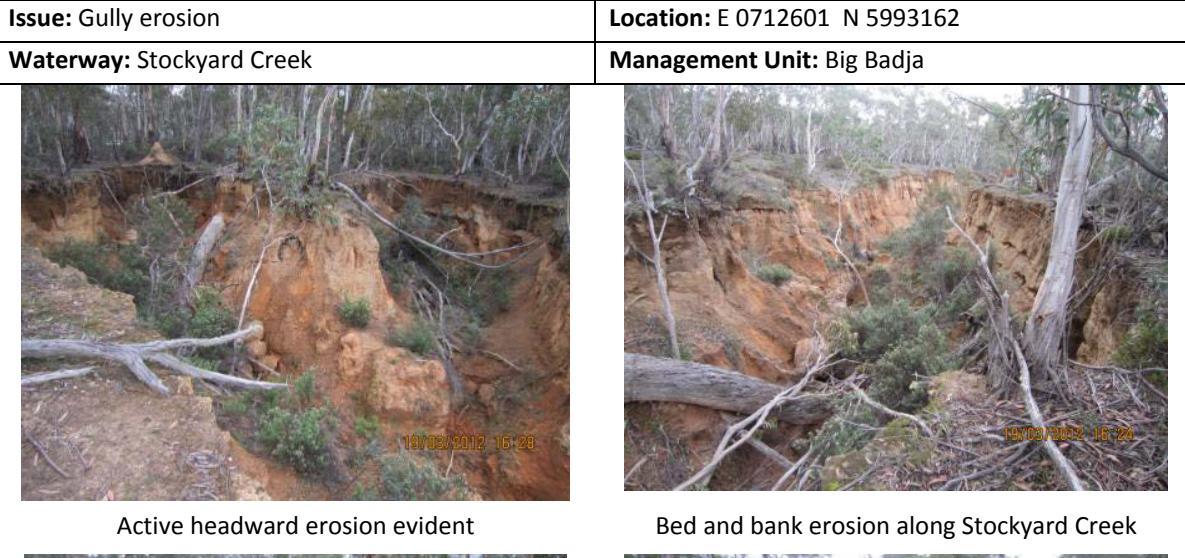
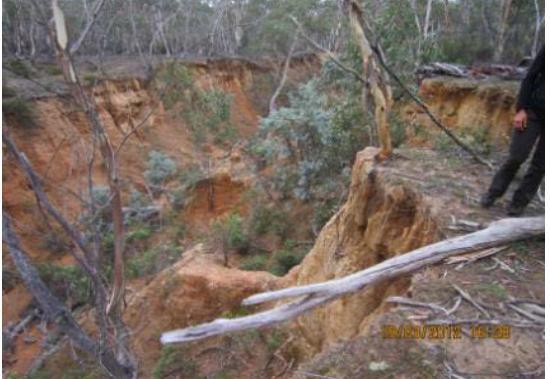
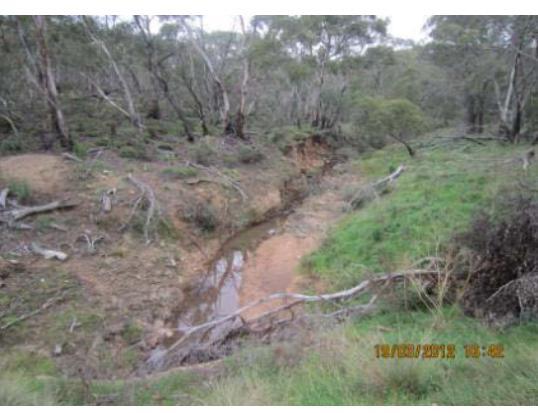
6.2.1 Site 1

Vegetation apparent on gully floor

Further downstream along Stockyard Creek

The gully at this location is 10m deep and 15-20m wide. It consists of fine red highly erodible silt/clay sediments. Sub-surface flows are important mechanism for continued erosion of the gully head and side walls. This gully flows into Big Badga River. This gully is assessed as having a high connectivity for fine sediments, however, there is a long transport distance to Murrumbidgee with opportunities for storage of sediments along channel margins and across floodplain storages.

Risk Assessment:				
Likelihood	Consequence	Trajectory	Risk	
3	4	4	48	
Diele Detter au Manuelaisela

Risk Rating: Very high

Management Option: Undertake banks stabilisation via rock beaching and grade control to reduce ongoing instabilities. Fencing and revegetation of site in consultation with landholder.

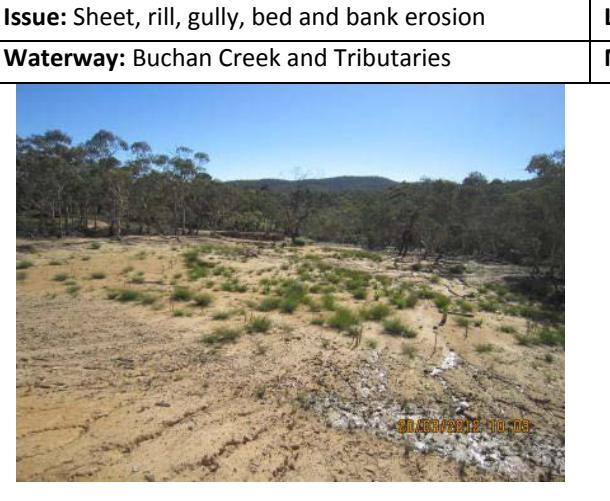
6.3.2 Site 3

Location: E 0700882 N 6009269 Management Unit: Bredbo

A steep cleared slope has been subjected to rill and gully erosion. This area has been historically cleared of vegetation, which has decreased the resistance of the ground surface to erosion. Attempts have been made to roughen rills with use of wooden control structures, with limited effect. A 2m headcut is evident at the confluence of the gully with Buchan Creek. It is likely that this headcut will extend headward and result

in further incision of the gully network. Downstream of the confluence of the gully with Buchan Creek, an 80m section of left bank, 4m in height, is evident. It is apparent that flows are actively undercutting banks.

Buchan Creek is assessed as having a high connectivity for fine sediments. Sediments eroded from gullied hillslopes and bed and banks of the creek are transported downstream along Buchan Creek. These sediments then pass directly into Bredbo River with high connectivity to the Murrumbidgee River.

It is possible that gravel/sand mining on Bredbo River has lowered the bed level of the river and incoming tributaries. The erosion problems documented along Buchan Creek may in part be due to the consequence associated with this downstream lowering of base level, which has then progressed up Buchan Creek leading to further incision of the drainage network.

Likelihood	Consequence	Trajectory	Risk
4	4	4	64
		•

Risk Rating: Extreme

Management Option: Undertake large woody debris stabilisation as alternative to rock beaching. Improve revegetation on site via mulching and revegetation.

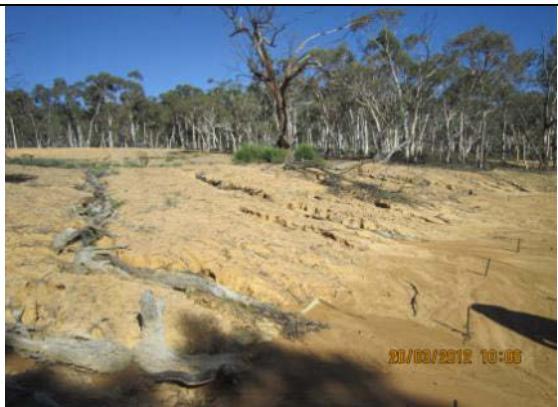
Sheet and rill erosion where land has been cleared of vegetation

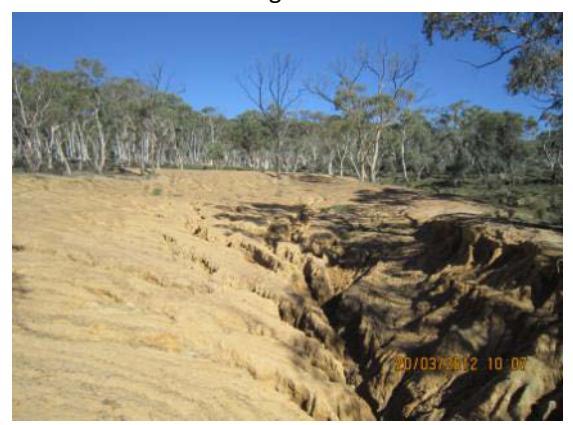
Gullies forming, at bottom slope of cleared area

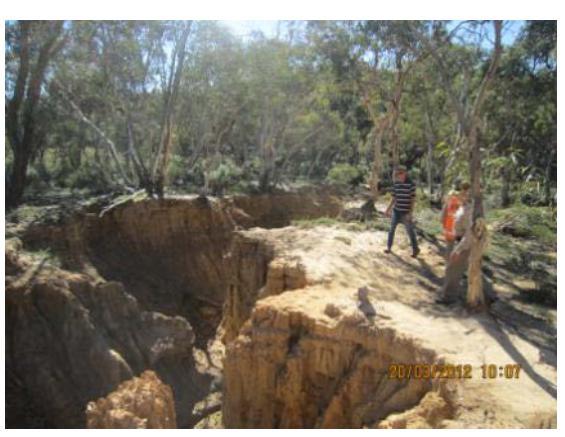
Headward erosion at tributary confluence with Buchan Creek

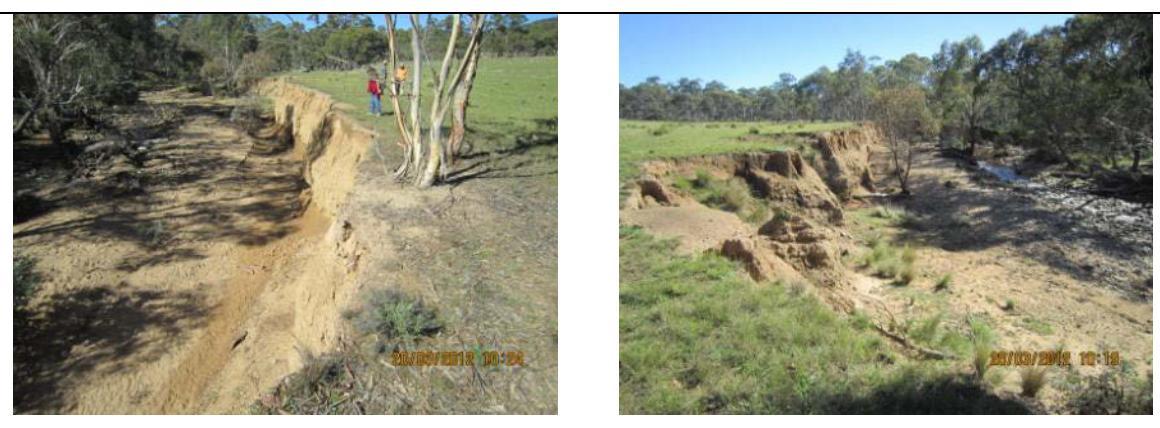
Bank erosion Buchan Creek

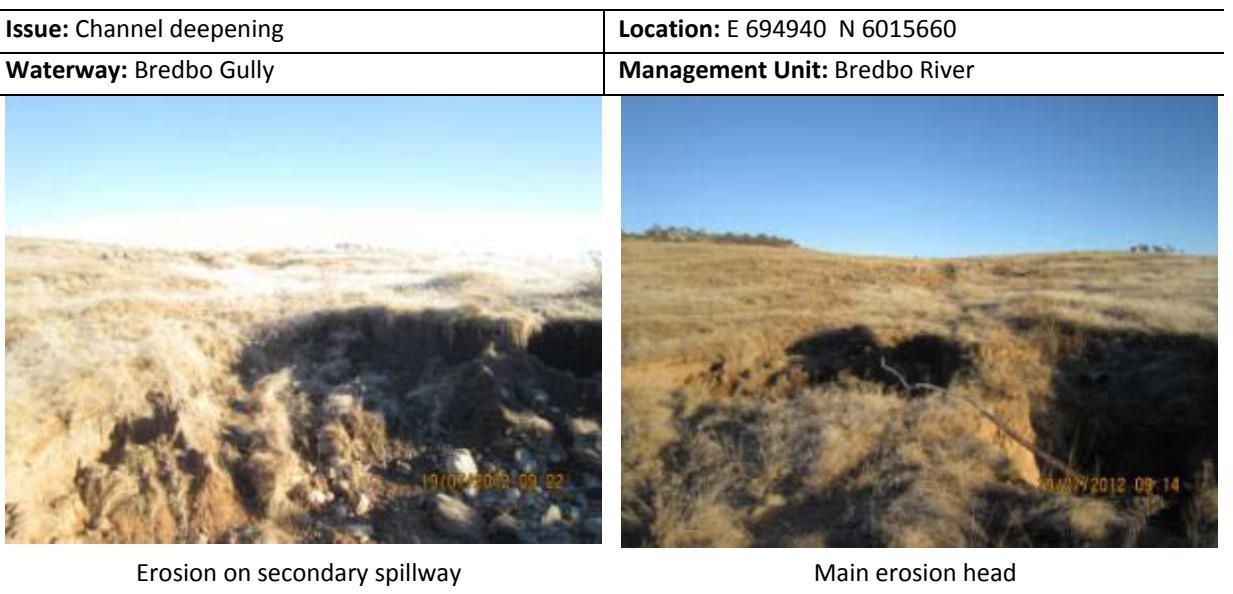
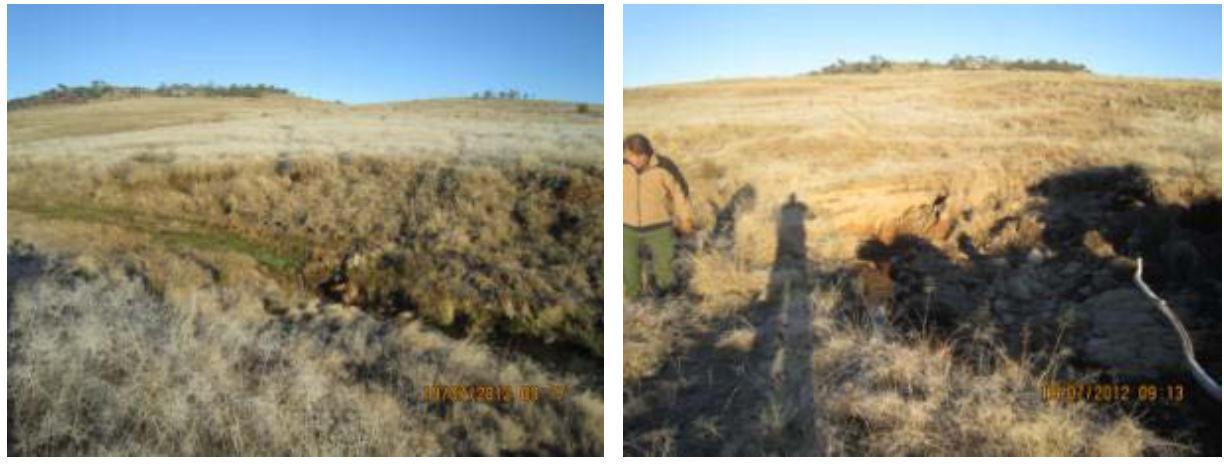
6.3.3 Site 4

Deepening downstream of dam

Primary erosion

This site is located on a gully directly connected to the Bredbo River. The dam is spilling in two directions with both spillways actively eroding. Furthermore a headcut in the gully downstream of the dam is likely to cause further deepening in the longer term. It would appear most appropriate to construct a rock chute on the main gully, back fill the left hand spillway and widen and stabilise the right hand spillway.

Risk Assessment:			
Likelihood	Consequence	Trajectory	Risk
4	4	4	64
Risk Rating: Extreme

Management Option: Backfill left side spillway, rebuild right side spillway and redefine existing contour banks to manage erosion in the vicinity of the dam. Construct ne rock chute downstream of dam to manage issue of gully deepening. Fencing and revegetation of the site should be undertaken in consultation with landholder.

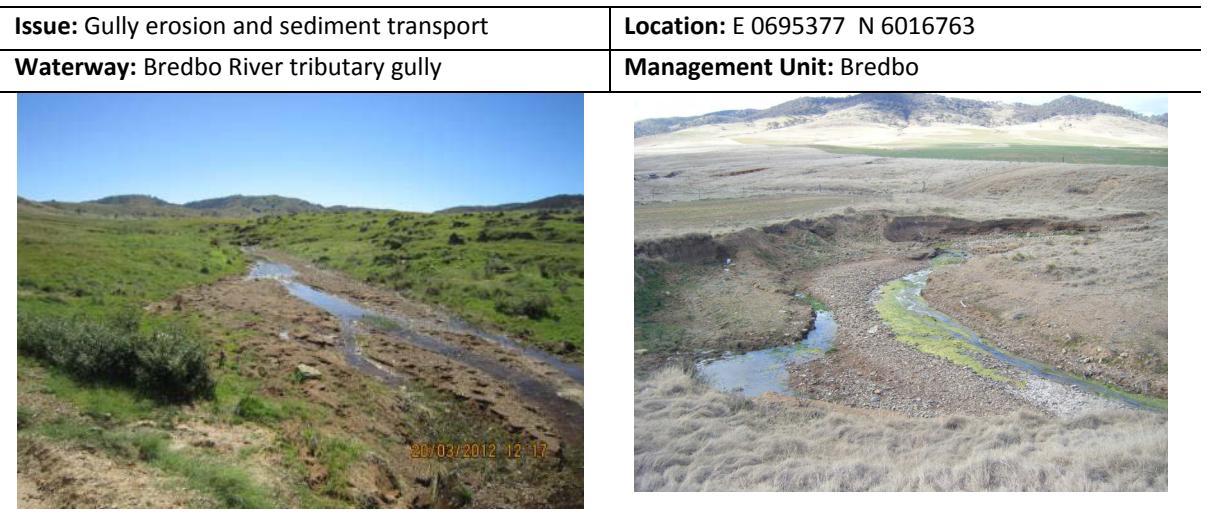
6.3.6 Site 7

Un-named Bredbo tributary

Gully erosion upstream of un-named Bredbo tributary

This gully carries runoff from a large subcatchment and is accommodating the transfer of sand and other fine sediments downstream. It has been assessed as having a high connectivity for fine sediments, given the apparent high mobility of sand. It is unsure how much fine sediment is being delivered from this catchment, however the historic gully erosion network upstream from this point indicates the potential for increased sediment loads.

Likelihood	Consequence	Trajectory	Risk
4	3	3	36
Diek Deting, Lligh

Risk Rating: High

Management Option: Construction of rock chute/sediment trap at confluence to manage bed deepening and to reduce sediment transport. Fencing and revegetation of site in consultation with landholder.

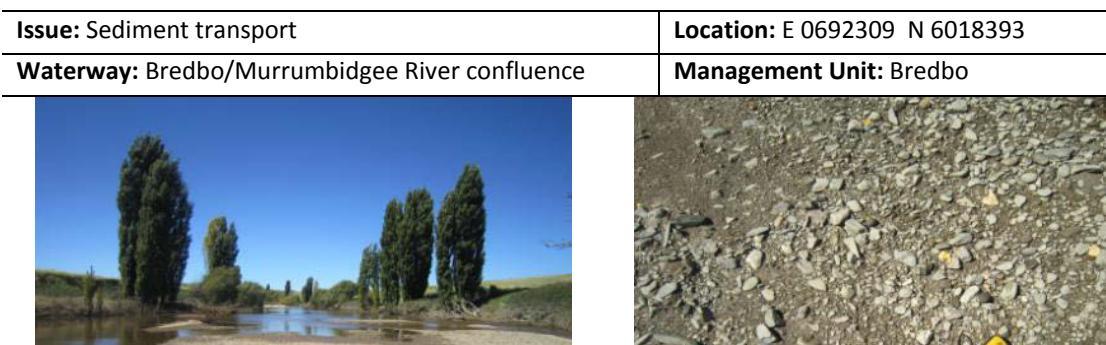
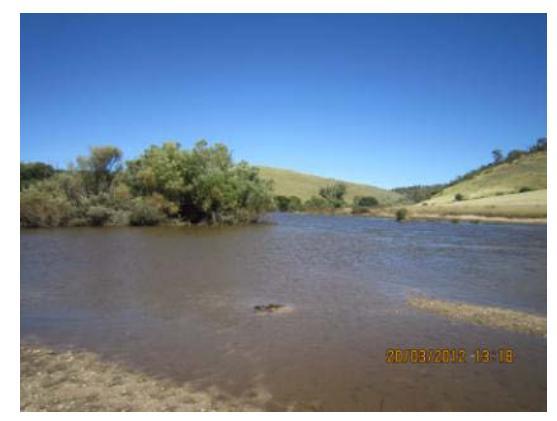
6.3.7 Site 8

Facing downstream of confluence

Very coarse gravel deposited on bed

Risk Assessment:LikelihoodConsequenceTrajectoryRisk4128

This site is situated at the Bredbo and Murrumbidgee confluence. Cobble/gravel/sand bed load and stable banks are present at this site. A high connectivity for fine sediments mobilisation has been assumed.

Risk Rating: Low

Management Option: No structural works recommended. Fencing and revegetation of site recommended in consultation with landholder.

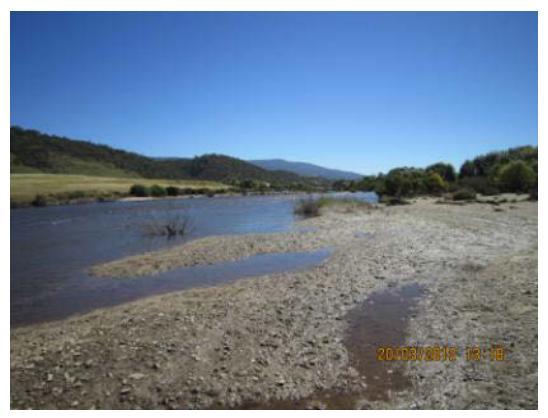
Facing upstream of confluence
