6.7 Murrumbidgee 1 South

UPPER MURRUMBIDGEE

ACTIONS for CLEAN WATER PLAN

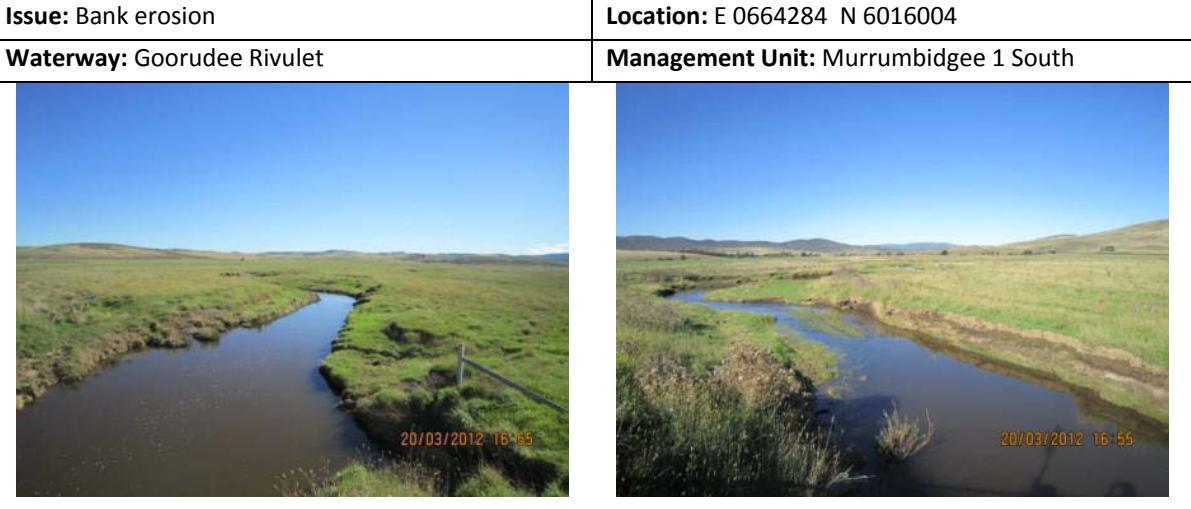
6.7.1 Site 26

Facing upstream from Bobeyan Rd crossing

Facing downstream from Bobeyan Rd crossing

A highly sinuous channel across broad low gradient valley with clay banks and fringing grasses. A potential source of sediment but would anticipate a low sediment delivery ratio. This site has been assessed as having medium connectivity for fine sediments due to long travel distance to Murrumbidgee water extraction point with opportunities for storage along channel margins and across floodplain storages.

Risk Assessment:			
Likelihood	Consequence	Trajectory	Risk
2	3	3-4	18-24

Risk Rating: Moderate

Management Option: Install rock beaching to mitigate river bank erosion. Fencing and revegetation to be implemented in consultation with the landholder.

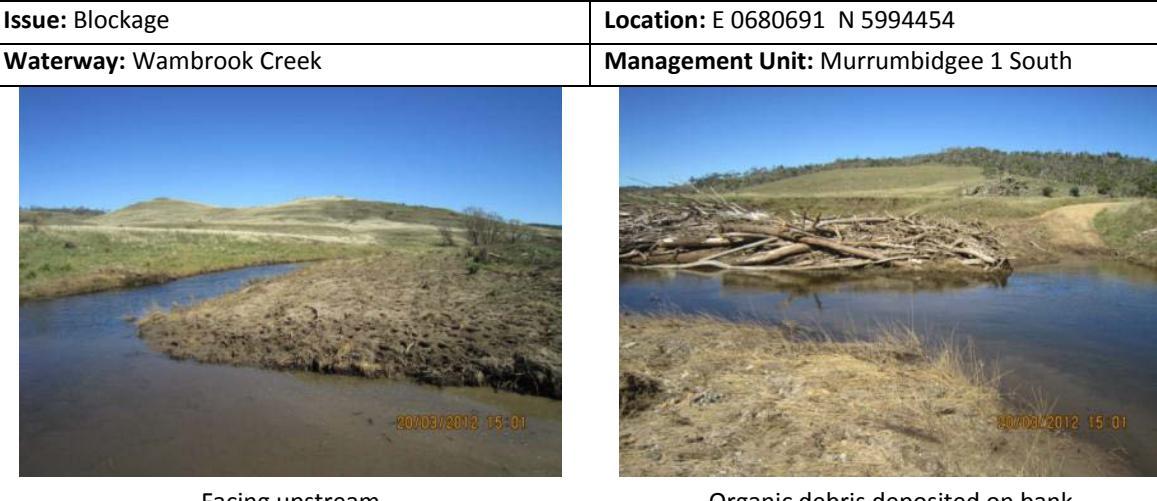
6.7.3 Site 28

Facing upstream

Several sites of log jams upstream of the site identified between site 24 and the junction of Wambrook Creek and the Snowy Mountains Highway. Landholder has indicated that there are some areas of moderate bank erosion downstream of this site. A debris jam is located at this site along Wambrook Creek. A large amount of fine sediment and organic material has been deposited along the bank. Assessed as having medium connectivity for fine sediments due to long travel distance to Murrumbidgee water extraction point with opportunities for intermediate storage along channel margins and across floodplain storages.

Risk Assessment:			
Likelihood	Consequence	Trajectory	Risk
3	2	3	18
Risk Rating: Moderate	·	·	•

Management Option: Relocate debris blockage. Fencing and revegetation of site recommended in consultation with the landholder.

Inspect additional locations in the vicinity of this site to identify if other sites of turbidity generation are present.

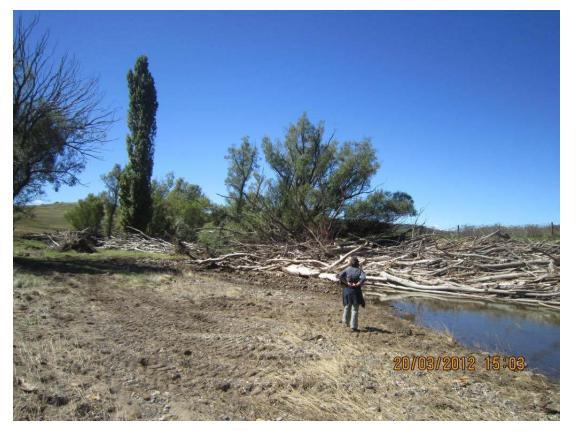
Downstream build-up of organic material

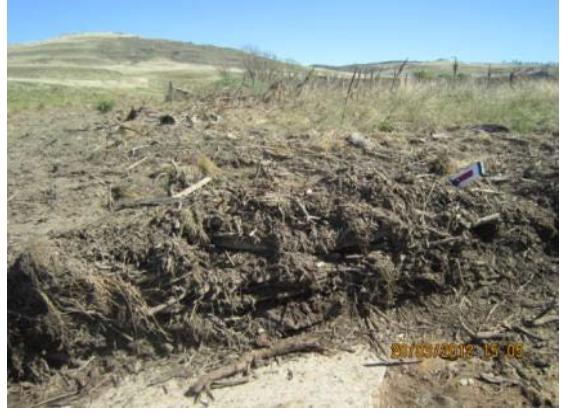
Debris deposited on floodplain

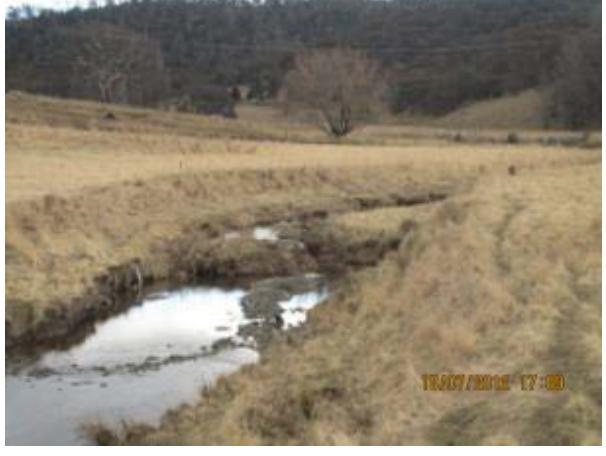
Bed deepening upstream of Snowy Mtns Hwy

Wambrook Creek appears to have isolated head cuts over much of its length upstream and downstream of Snowy Mountains Highway. This has the potential to lead to deepening, widening and sediment generation. It would appear appropriate to identify all potential heads via a longitudinal survey. Where destabilising erosion is identified, rock chutes could be constructed to manage sediment generation. This site immediately upstream of the highway is a highly visible site, which could be managed to show the benefits of sediment stabilisation.

Likelihood	Consequence	Trajectory	Risk
4	3	3	36

Risk Rating: High

Management Option: Construction of Rock chute to manage bed deepening in the Creek. Fencing and revegetation to be undertaken in consultation with the landholder.

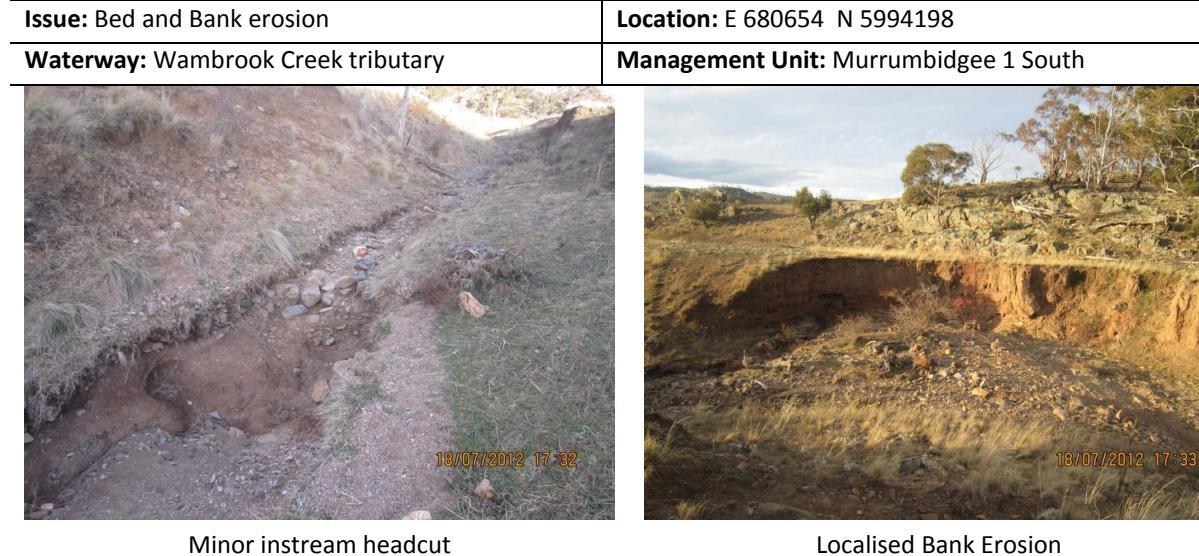
6.7.5 Site 30

Rock Bar 220m upstream of confluence with Wambrook Creek

This site flows directly into Wambrook Creek at Wambrook Crossing. The gully is a relatively steep high energy gully with localised bank erosion and minor bed deepening over 20m of length upstream of Wambrook Creek. The bed load is coarse gravel which will continue to generate small loads into Wambrook Creek over time. A rock bar 220m upstream of the confluence limits the potential for ongoing deepening. The site would benefit from stock exclusion.

Risk Assessment:			
Likelihood	Consequence	Trajectory	Risk
4	2	2	16
Risk Rating: Moderate			
Management Option: Und	dertake fencing and reveg	etation of the site in consul	tation with the landholder.

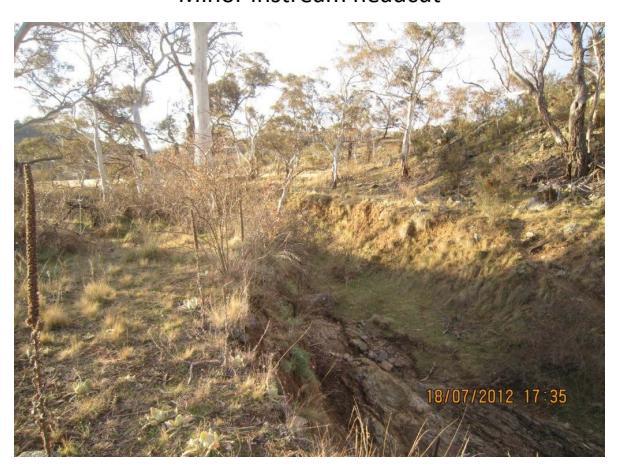
Coarse sediment migrating downstream

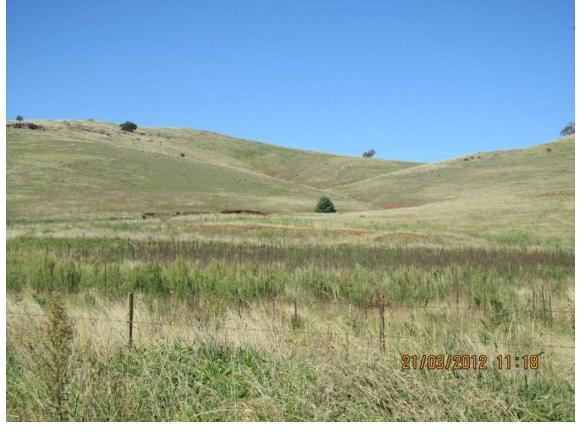
Moderate vegetation present along Ryries Creek

Disconnected gully in Michelago Valley. It has been assessed as low connectivity for fine sediment transfer.

ikelihood.	Consequence	Trajectory	Risk
2	3	2	12

Risk Rating: Low

Management Option: No structural works recommended. Fencing and revegetation of site recommended in consultation with the landholder.

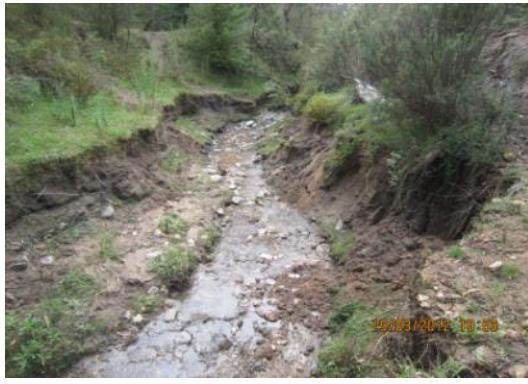
Coarse sediment transfer down gully

Fine sediments and coarse sandy material are actively being eroded from the gully network upstream of gully plug dam. Coarse sediment is settling out prior to the dam, however, a high proportion of fines are likely to be transported beyond the dam and deposited further downstream along the valley floor. These eroded areas are assessed as having a low connectivity for fine sediments as eroded sediments are stored along the valley of Reedy Creek.

Management Option: No structural works recommended. Fencing and revegetation of site recommended in consultation with the landholder.

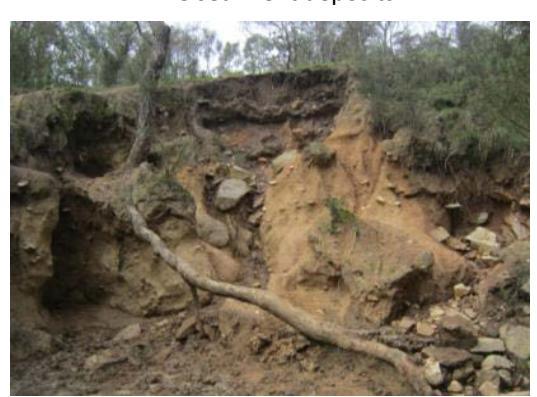
Existing headcut

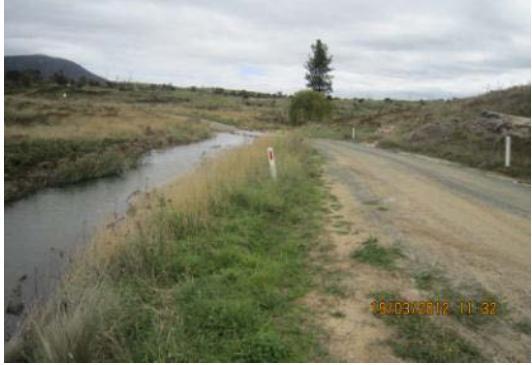
Crossing on Reedy Creek

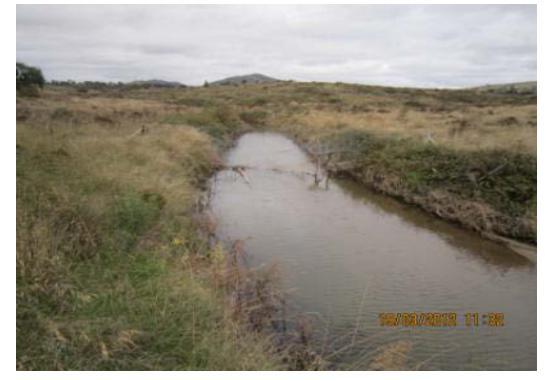
Confined Reedy Creek channel

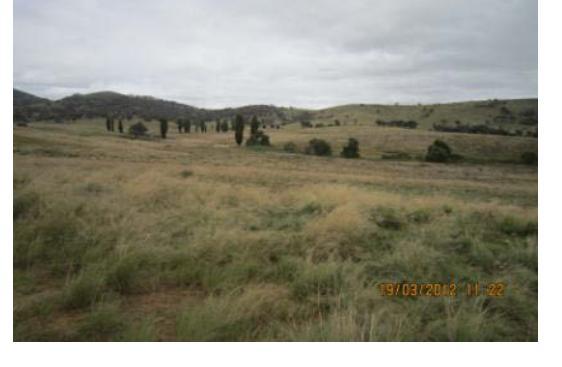
Looking across the valley

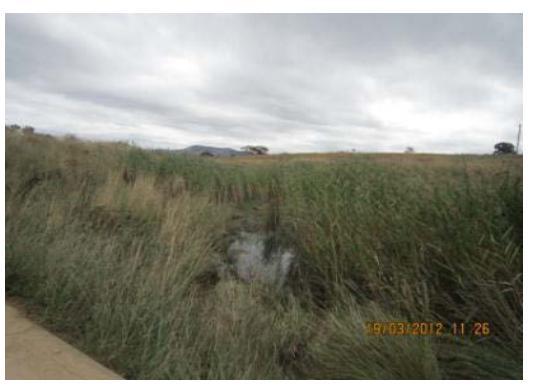
Phragmites present along banks

This site along Reedy Creek appears to be stable with Phragmites established within bed. Reedy creek in this location is characterised by a broad valley which is presently functioning as a large sediment storage zone for fine and coarse sediments which have been eroded from areas further upstream. This site is assessed as having a low connectivity for fine sediments as eroded sediments are stored along valley of Reedy Creek which is functioning as a sediment sink.

Management Option: Undertake fencing of the site to exclude stock to encourage the ongoing in-stream establishment of Phragmites.

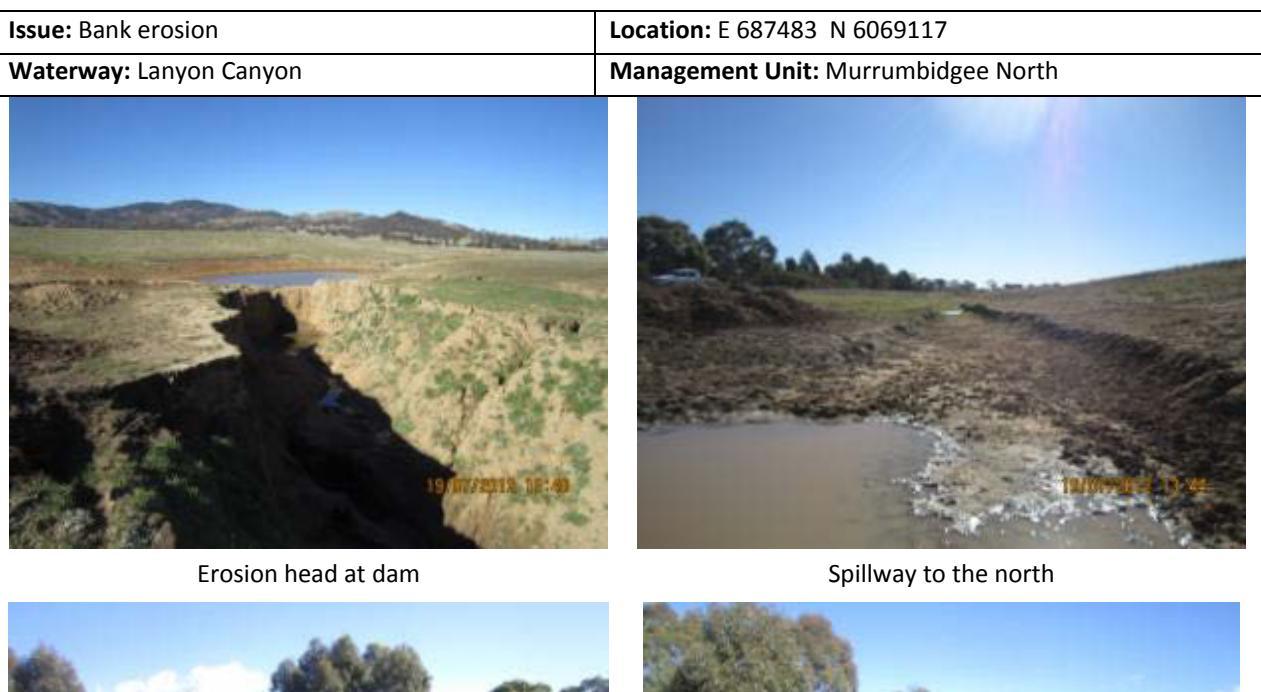
6.9.3 Site 34

Looking past fence to Murrumbidgee River

This site is known locally as the Lanyon Canyon. It consists of an erosion head approximately 5m high, which drops approximately 10m into the Murrumbidgee River. It would appear burrowing by Wombats has encouraged tunnel erosion which has set off a major gullying episode in close proximity to the Murrumbidgee River. To stabilise the site, check banks should be constructed to encourage flow to spill to the north into a more stable flowpath.

Likelihood	Consequence	Trajectory	Risk
4	5	4	80
Risk Rating: Extreme

Management Option: Back fill existing scour hole with a clay bank. Face with rock beaching. Define northern spillway to improve overflow stability from the dam. Fencing and revegetation of site in consultation with landholder.

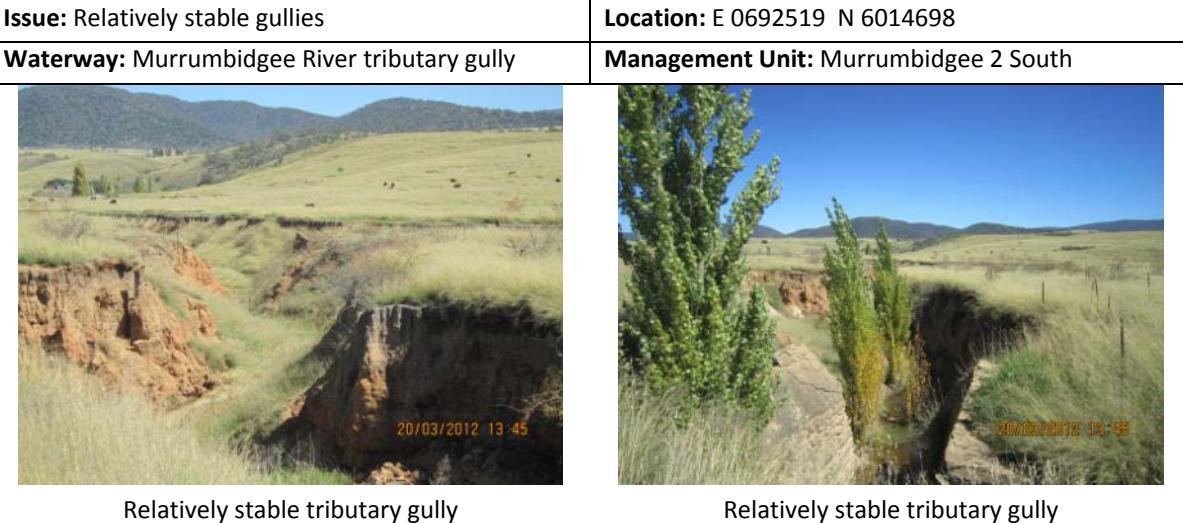
Relatively stable tributary gully

This gully appears to form a minor tributary of the Murrumbidgee River. Presently, the bed of the gully is well stabilised with a high amount of grassy vegetation present. Initial incision was attributed to stock gathering in drainage line, approximately adjacent to the shearing shed. This site has been assessed as having high connectivity for fine sediments; direct transfer of fine sediments from gully into Murrumbidgee.

Likelihood	Consequence	Trajectory	Risk
4	3	3	36

Risk Rating: High

Management Option: Construct a rock chute in gully to manage bed deepening. Fencing and revegetation to be undertaken in consultation with the landholder.

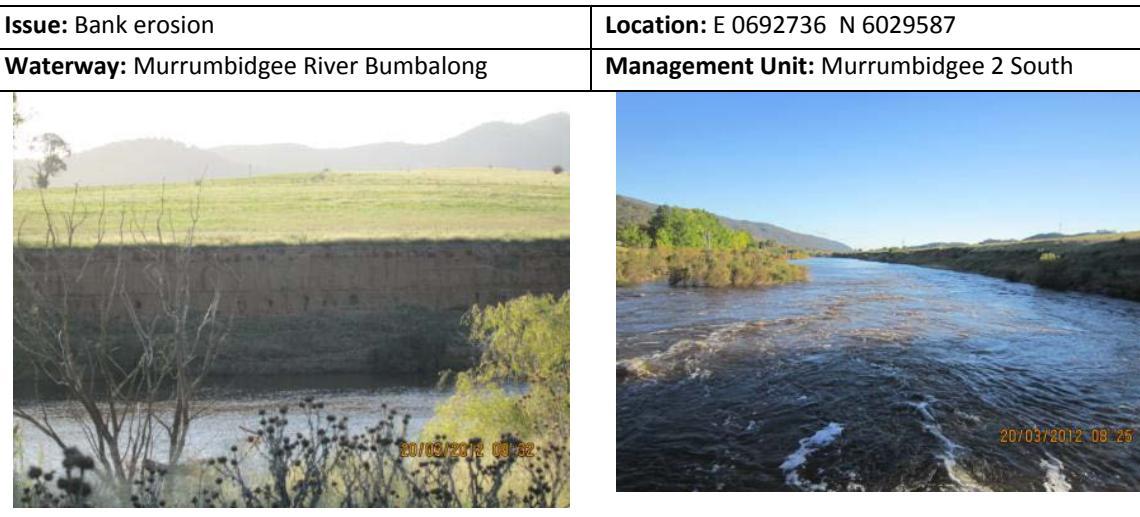
Widespread bank erosion along Murrumbidgee River

Bumbalong Rd crossing, facing downstream

Right bank of river over an extended length (700-800m) consists of vertical banks with grassed stable toe. Higher section of bank may be eroded during high flows, but overall condition of banks is considered to be in a stable state. Assessed as having a high connectivity for fine sediments, as fine sediments eroded from these banks are directly input into flow of Murrumbidgee River.

Risk Assessment:				
Likelihood	Consequence	Trajectory	Risk	
4	4	2	32

Risk Rating: High

Management Option: Stabilise toe and face of bank with rock beaching, complete fencing and revegetation of site in consultation with the landholder.

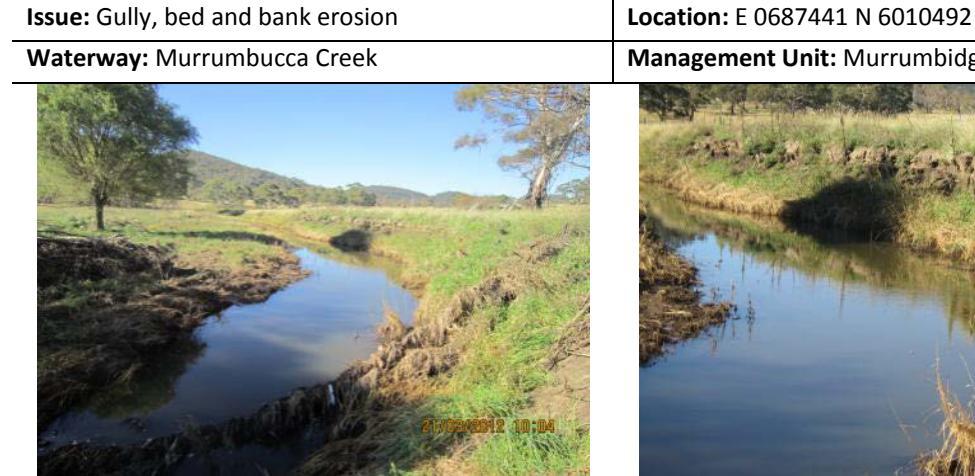
Murrumbucca Creek, facing upstream

Upstream of crossing, the silty/sand banks are eroding with minimal grassy vegetation present. Downstream of the crossing, bedrock control in channel is limiting further incision. This catchment appears to be a significant source of fine grained sediments to the Murrumbidgee. More significant incision, bank erosion and channel widening appears to be occurring in the lower reaches of this valley. This creek has been assessed as having high connectivity for fine sediments due to very fine grained sediments eroded from bed and banks of incising creek transferred efficiently to Murrumbidgee through gorge setting. This valley would once have been a swampy meadow, not an incised channel contributing large amount of sediments as it is today.

Risk Assessment: Likelihood Trajectory Risk Consequence 4 4-5 64-80 4

Risk Rating: Extreme

Management Option: Install rock beaching to manage bank erosion. Fencing and vegetation of site to be undertaken in consultation with the landholder.

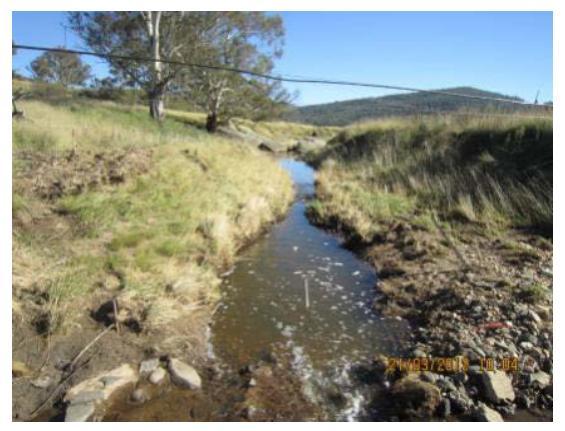
Murrumbucca Creek, facing downstream

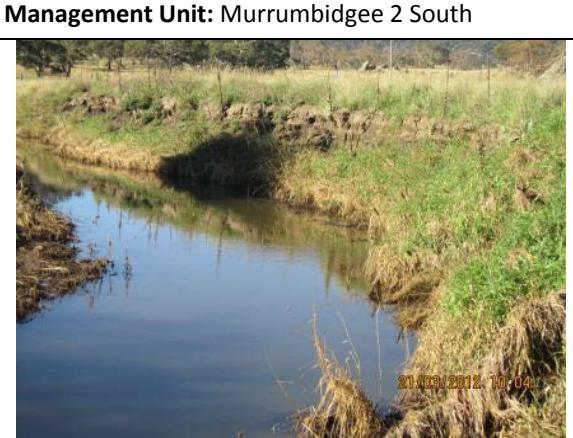
Localised bank erosion along creek

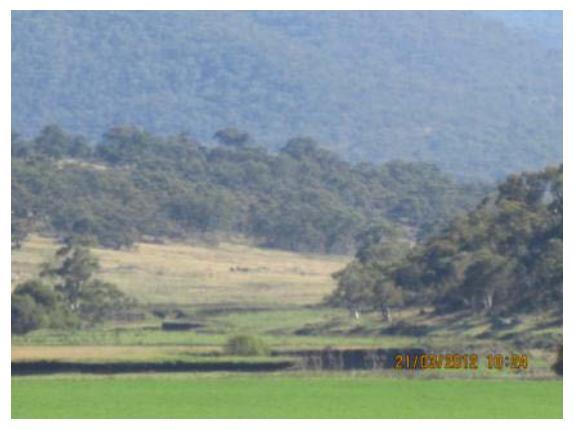
Bank erosion present along lower reaches
