ACTIONS for CLEAN WATER PLAN

ACWA PLAN

6.1 Condition assessments

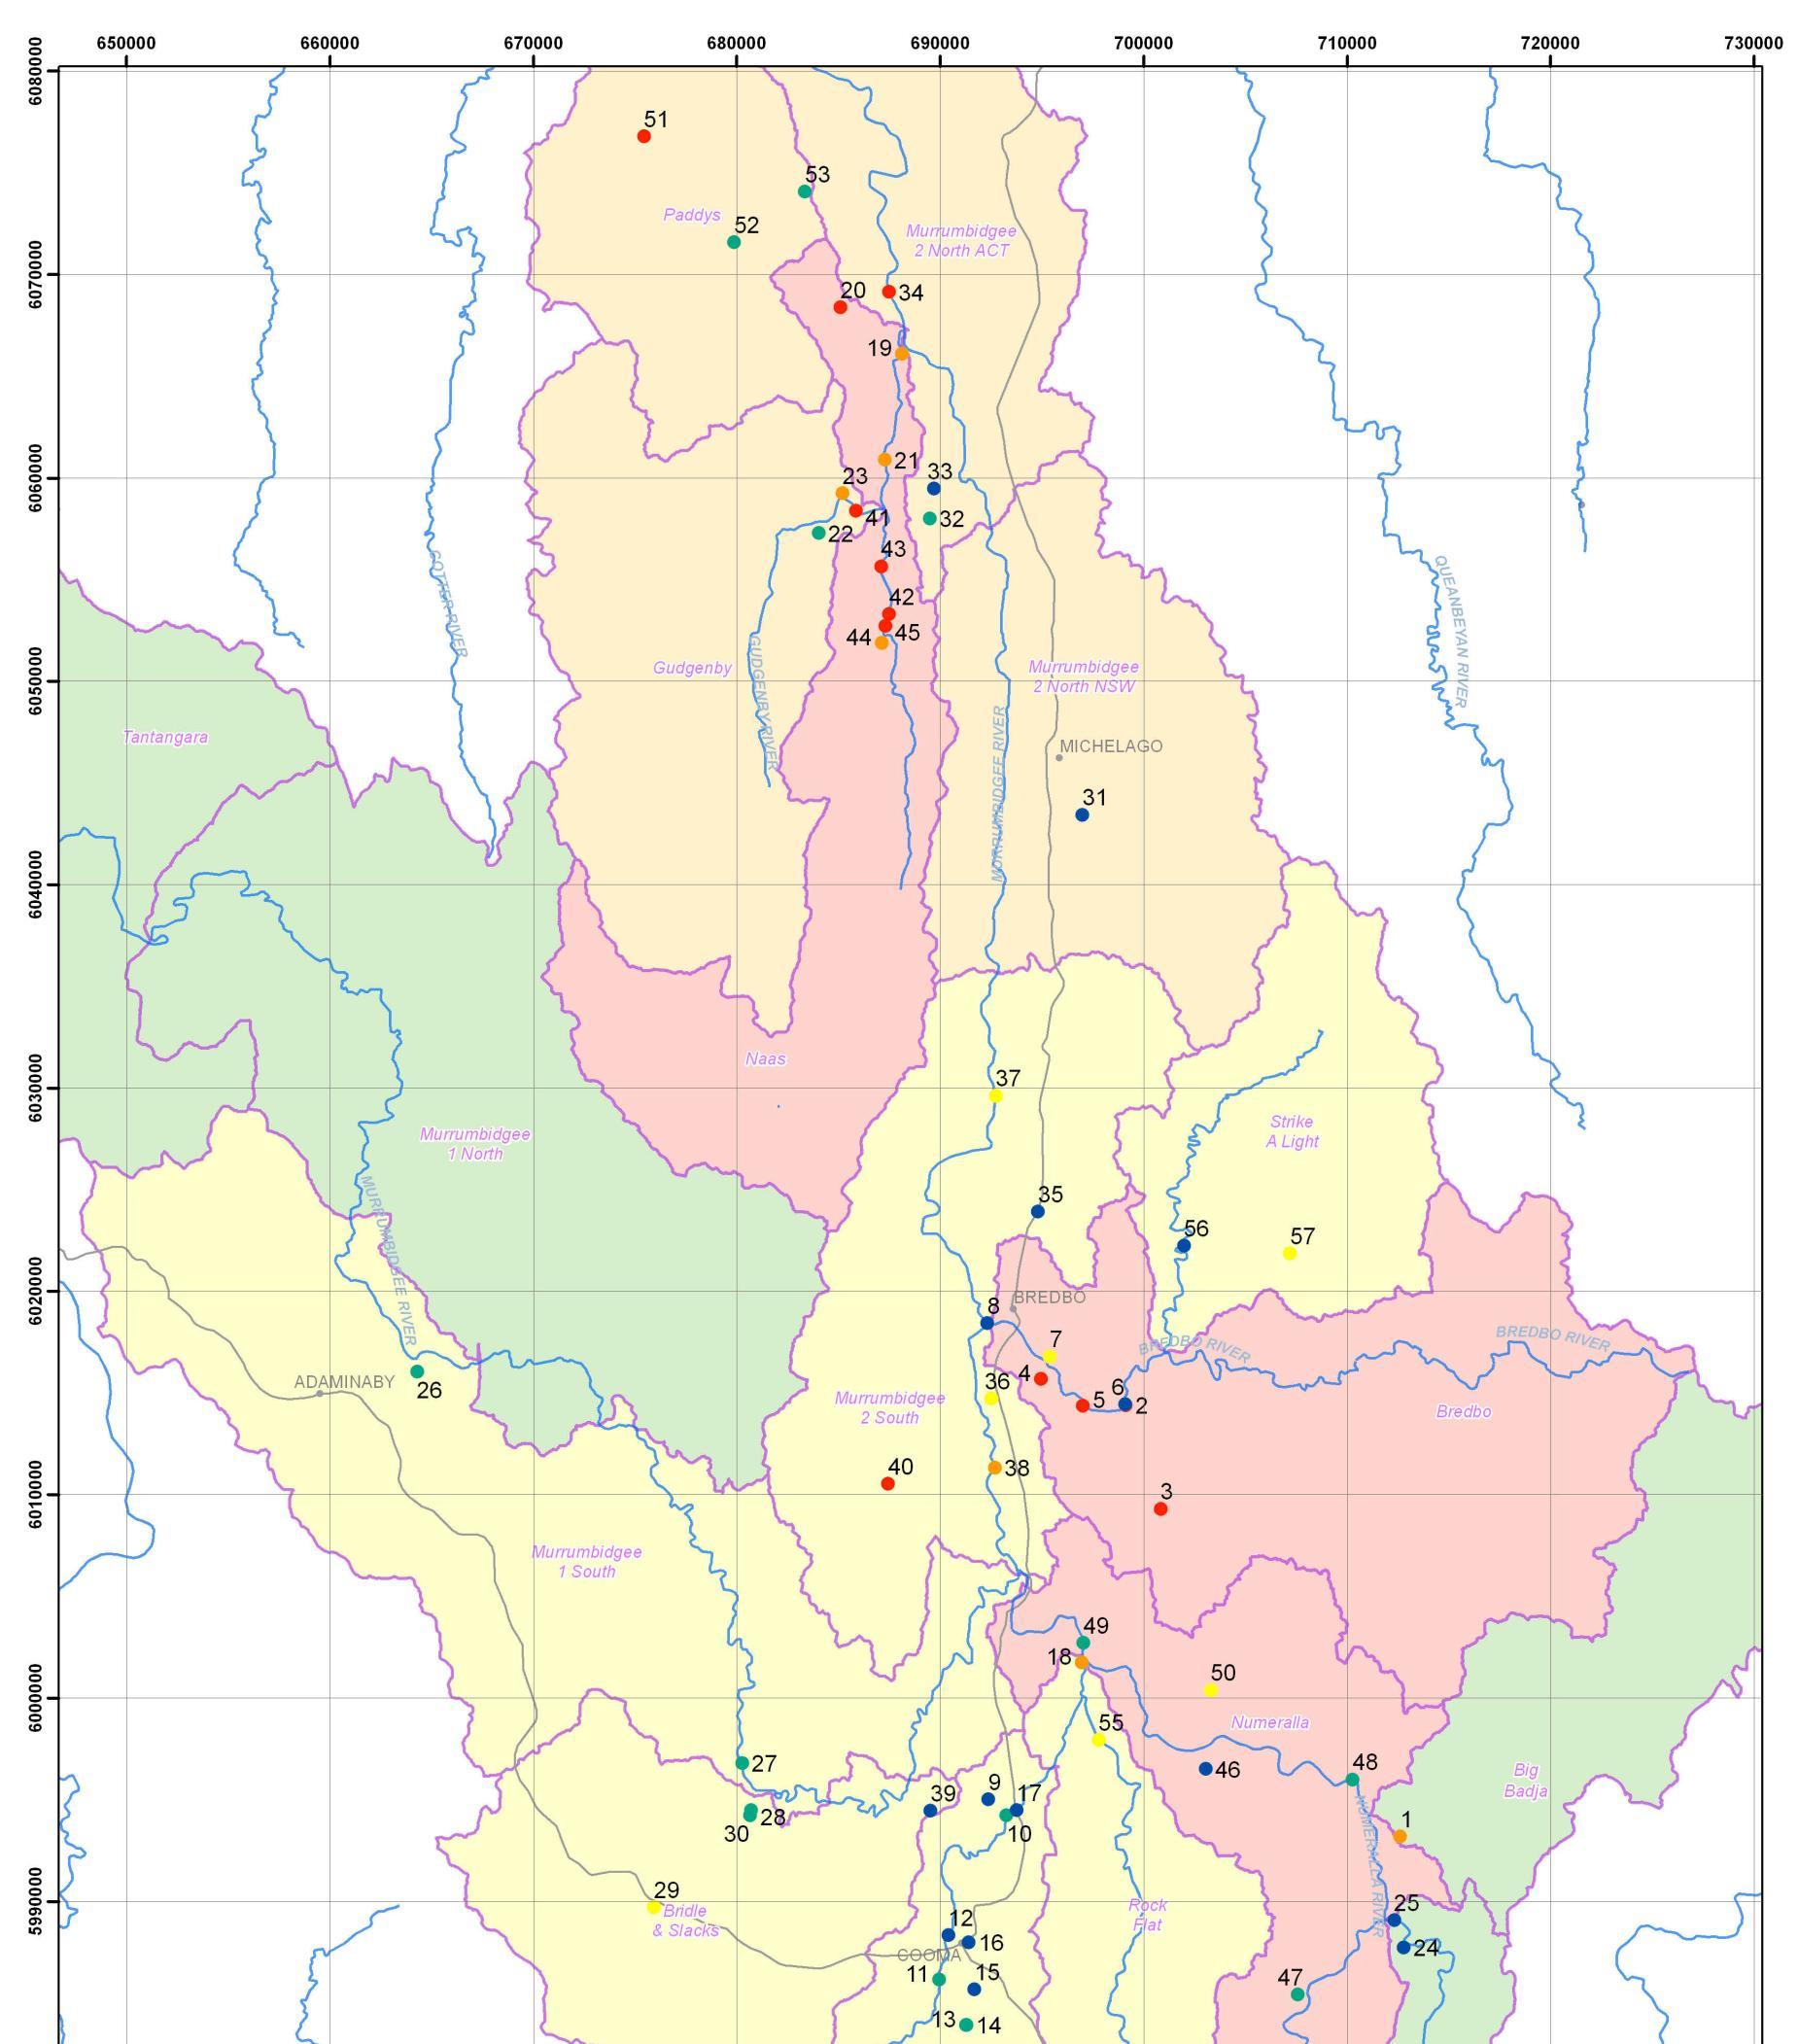
Figure 17 Locations of sites where condition assessments were completed and risk ratings calculated

The following figure presents the sites where condition assessments were undertaken and the risk rating calculated for each site.
