UPPER MURRUMBIDGEE ACTIONS for CLEAN WATER PLAN

Appendix A- Prioritisation Report

A consortium of natural resource management organisations in the Upper Murrumbidgee River catchment have come together to prepare an action plan (Actions for Clean Water - ACWA) to enhance surface water quality and reduce turbidity in the Upper Murrumbidgee River catchment within NSW and the ACT.

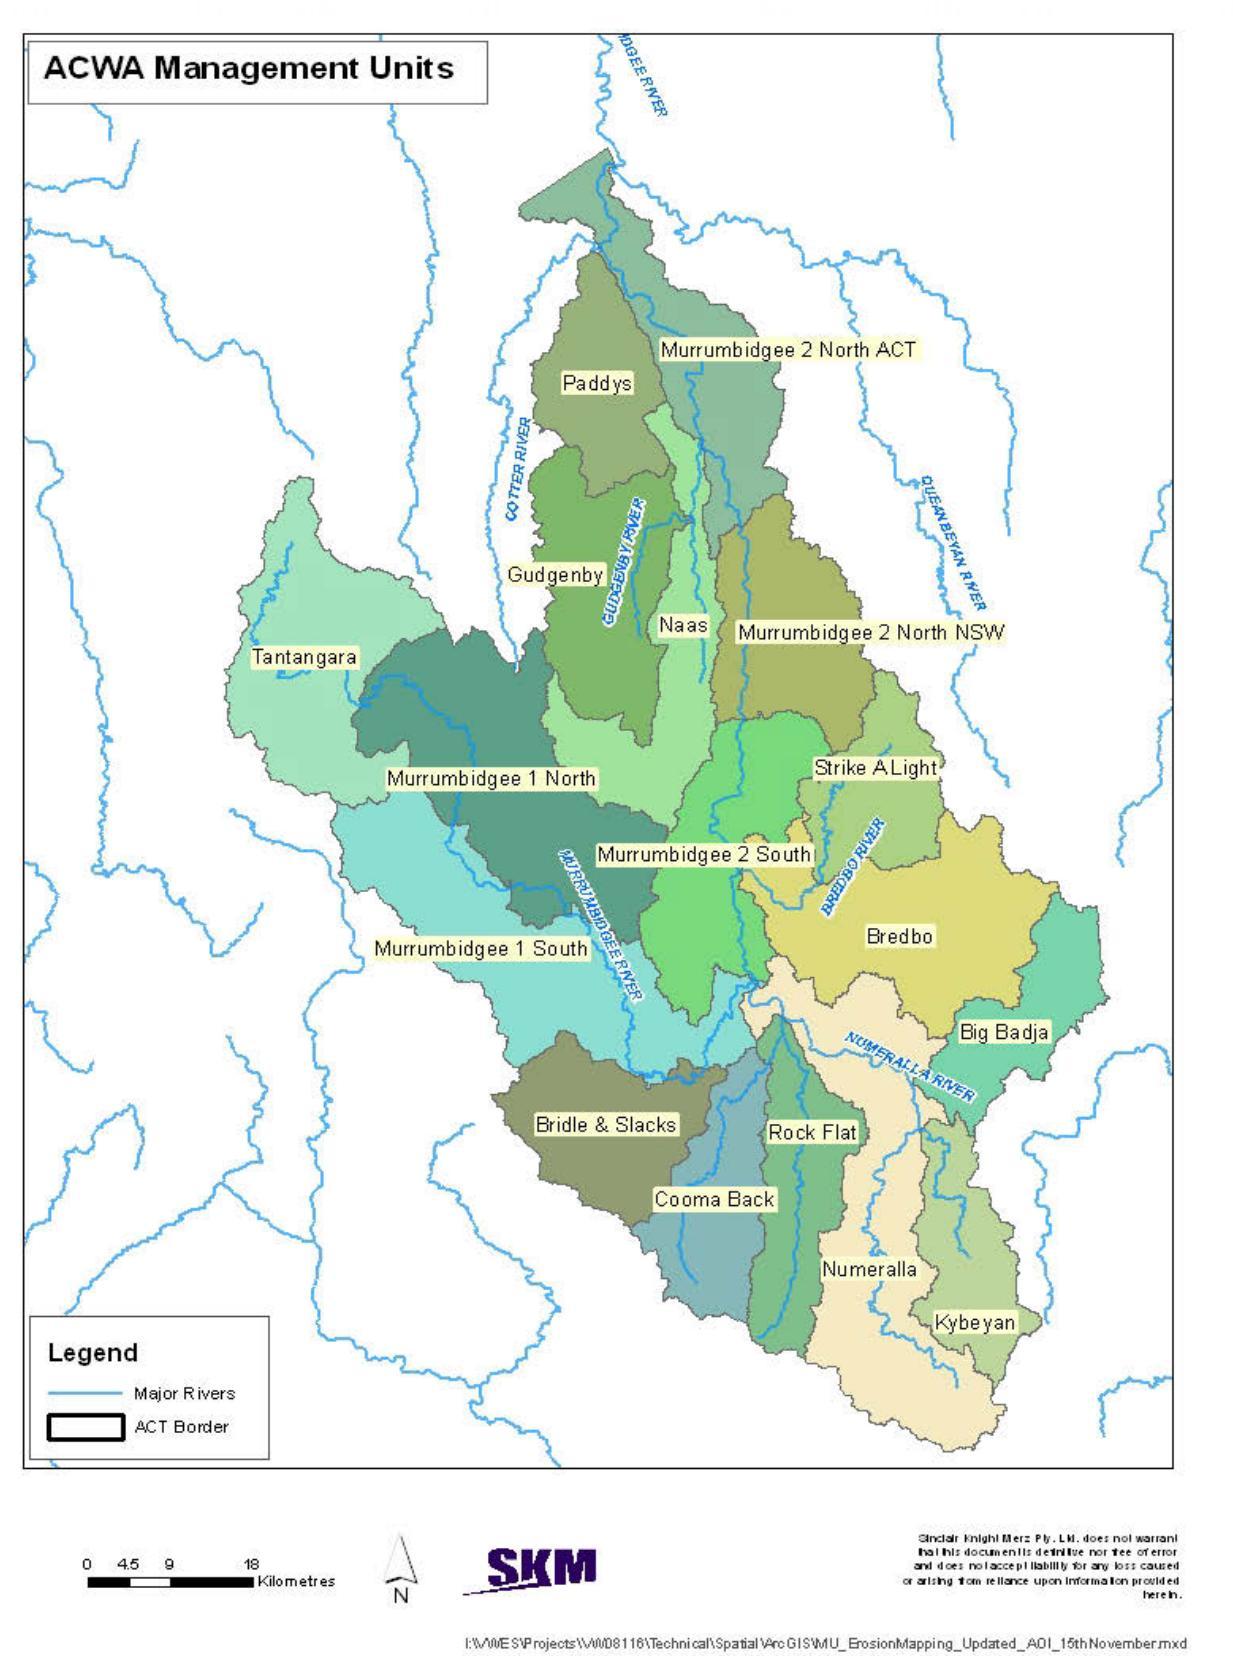
A Map of the Management Units is contained in Figure 4-1.

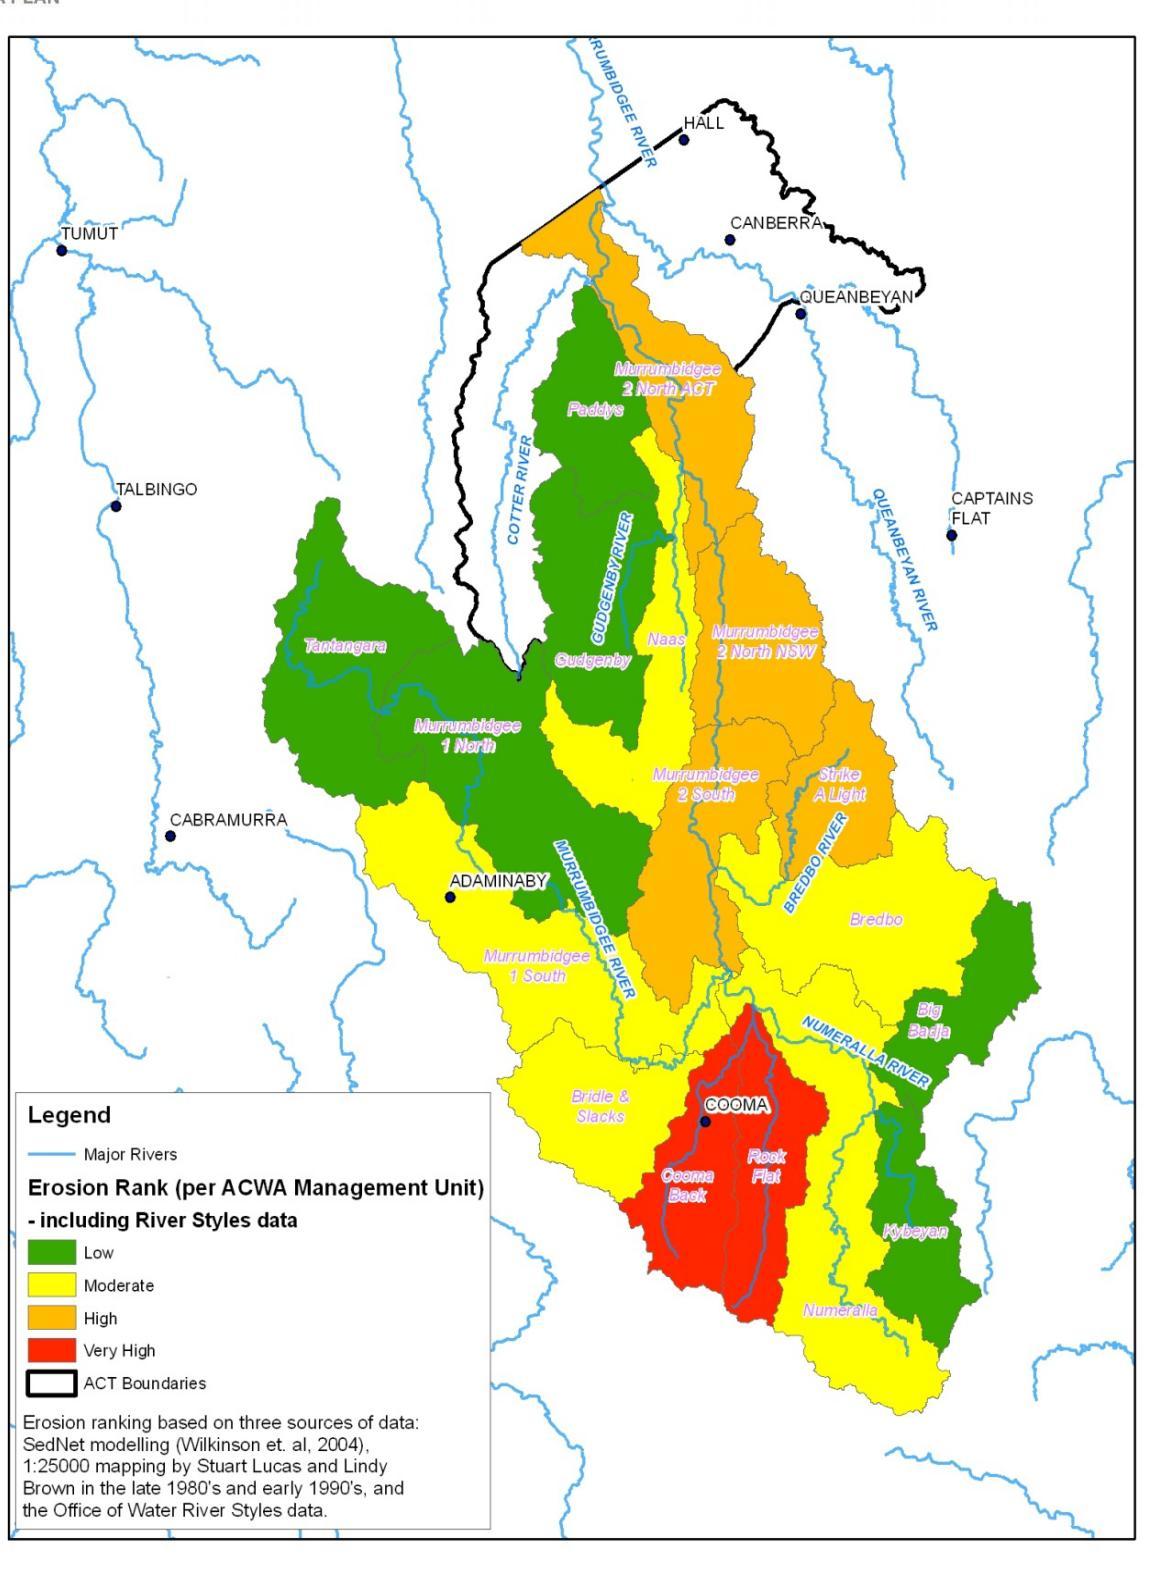
Figure 5-1 Priority Management Units from GIS Data Analysis

These three datasets have been chosen because they all contain information specifically related to the location and severity of erosion and/or sediment generation. The GIS Data Analysis recognises that each of these datasets have varying degrees of reliability and consideration is made of this through the analysis process. Specifically it is recognised that the SedNet data is modelled data only and hence cannot be considered to be definitive. Similarly the NSW Erosion Data has been collected over a period of time leading up to 2004 and so there is uncertainty about the reliability of this data give the period of time since its collection. Finally the River Styles data contained attributes relating to the confidence in the data and this is considered via the Analysis process. The outcome of this process is shown in Figure 5-1.

Six Management Units were identified as being either a high erosion risk (Murrumbidgee 1 South, Murrumbidgee 2 North (ACT) Murrumbidgee 2 North (NSW) and Murrumbidgee 2 South) or very high erosion risk (Cooma Back and Rock Flat)). These Management Units are highlighted as potentially being a priority in terms of further field based investigations.

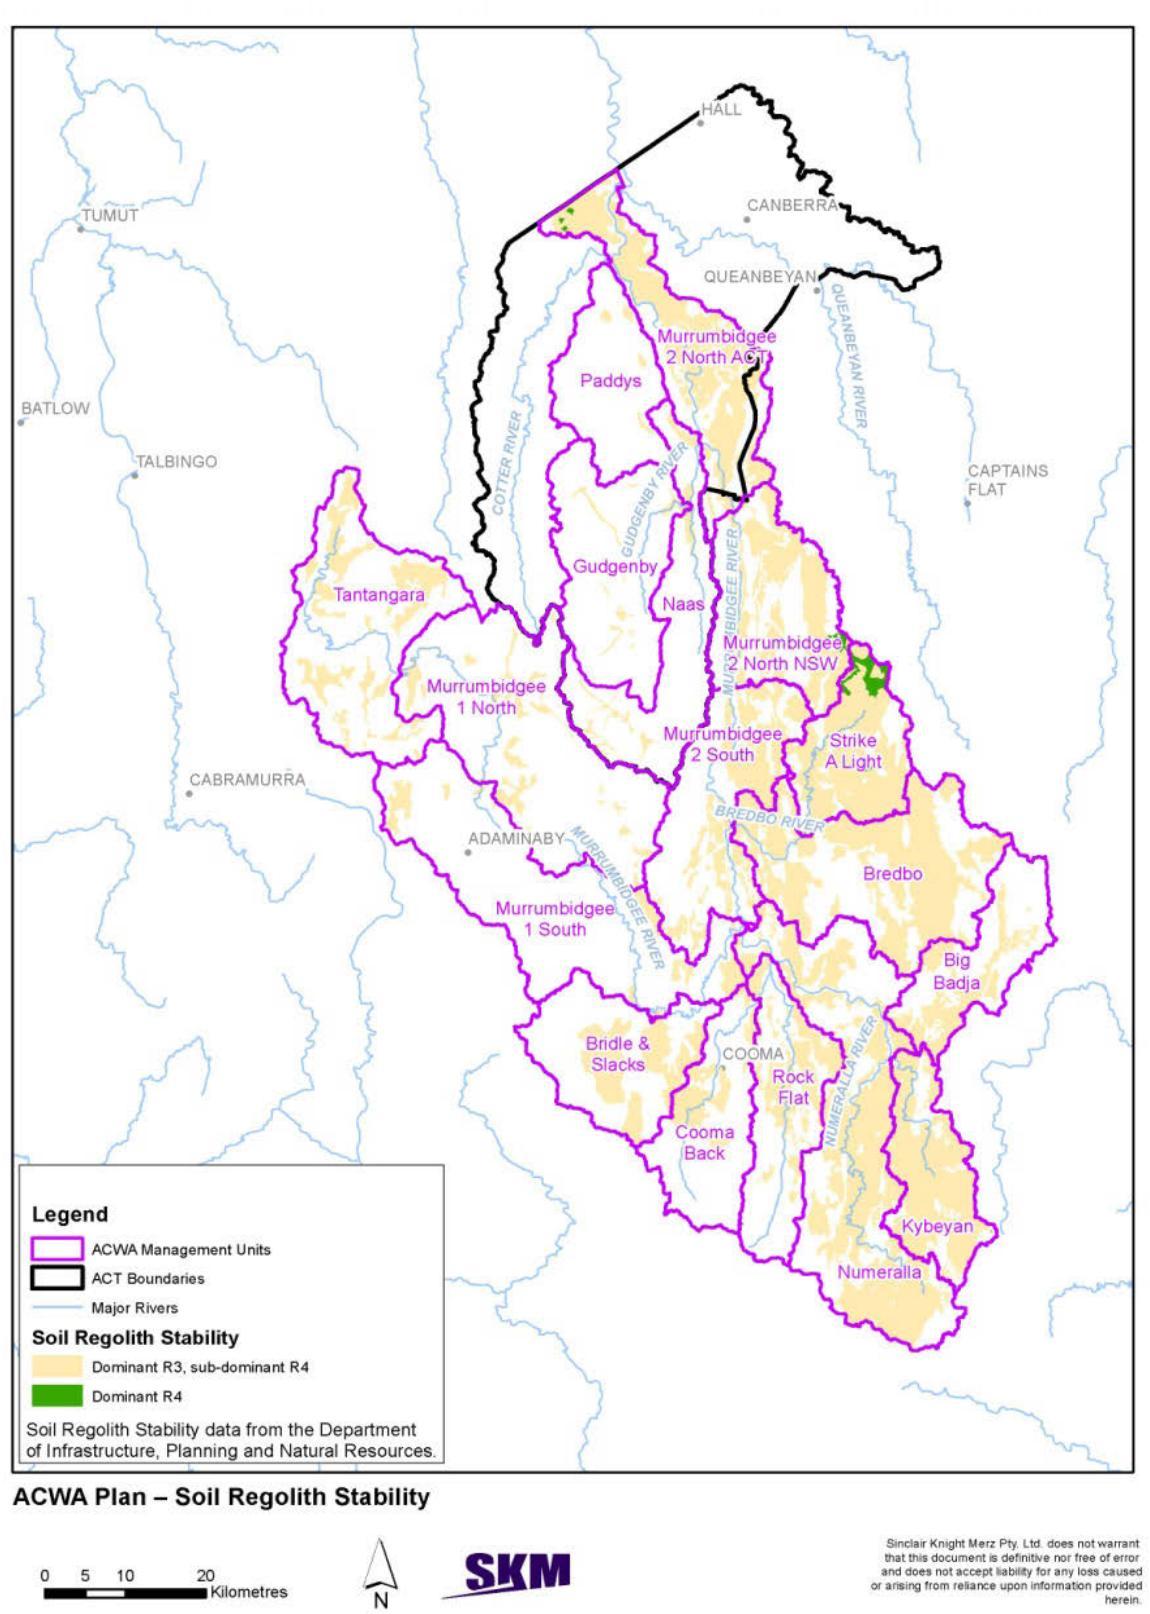
Figure 5-2 Distribution of Regolith Class R4 and R3 (R4) Soils in the ACWA Plan area

In the context of this project Regolith Class R4 is of the greatest interest because soils of this class have a high potential to release fine sediment which could contribute to downstream turbidity.

Of secondary interest are Regolith Class R3 soils (dominant class) that contain sub-dominant R4 soils. Soils of these two types are mapped in Figure 5-2 (below).
